Wind impacts on buildings in Hong Kong due to Mangkhut

2018 Typhoon Mangkhut window damage
in Hong Kong - some unforgettable
images

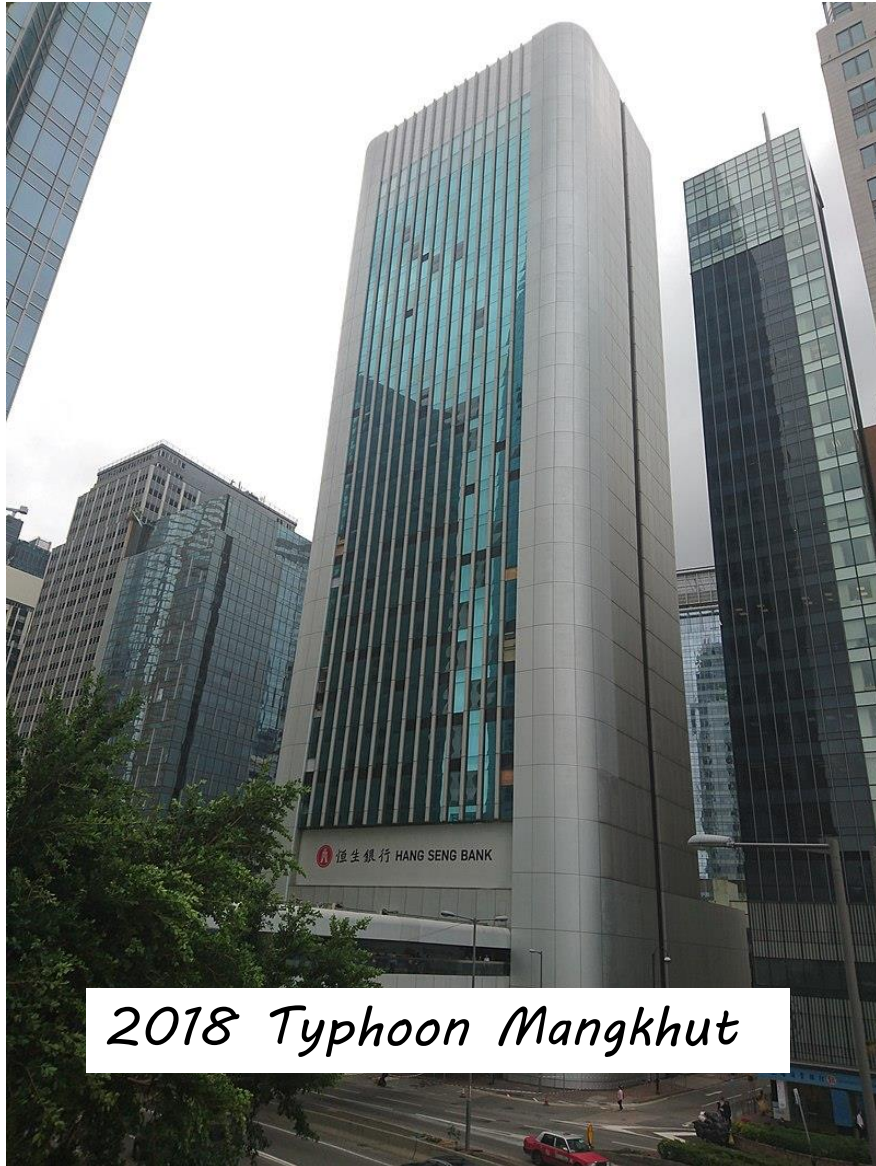
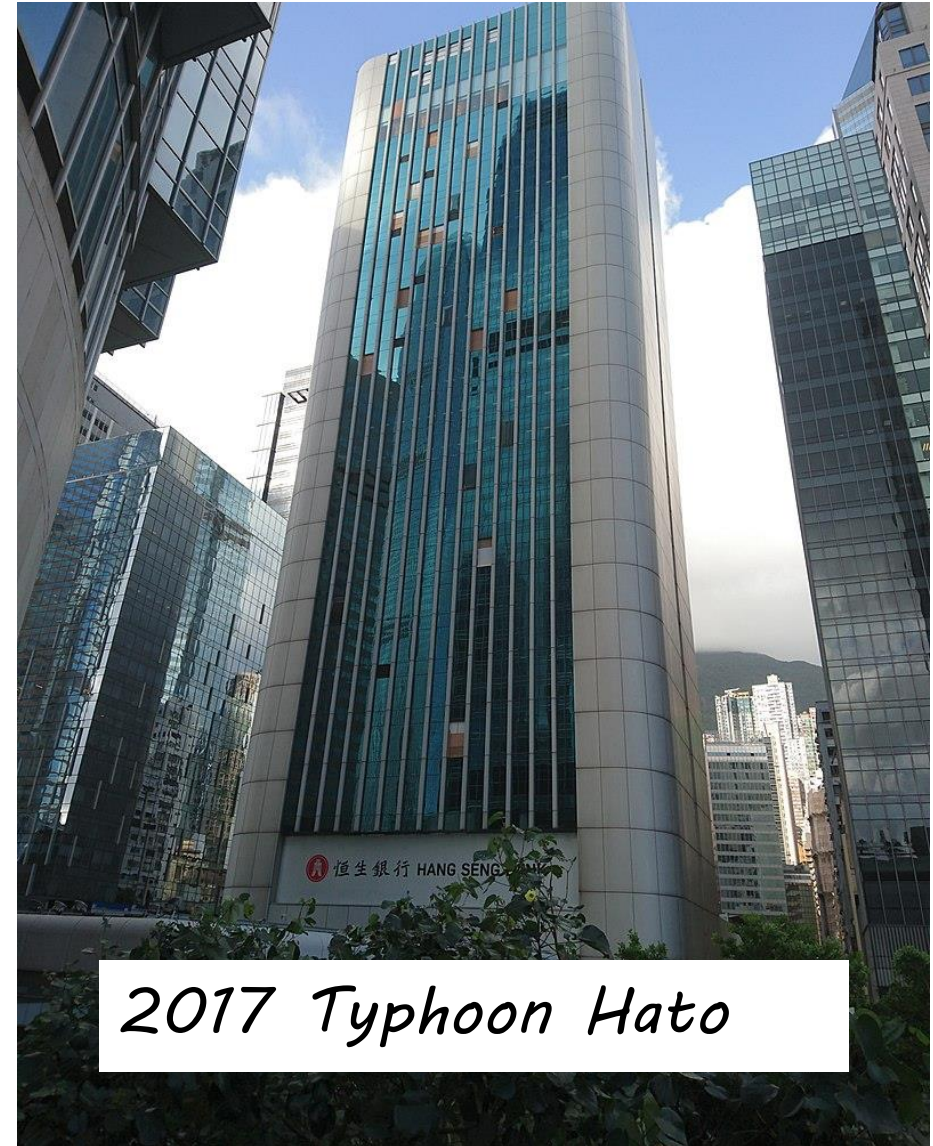
At least reported in two typhoons with Hang Seng Bank Headquarters Building

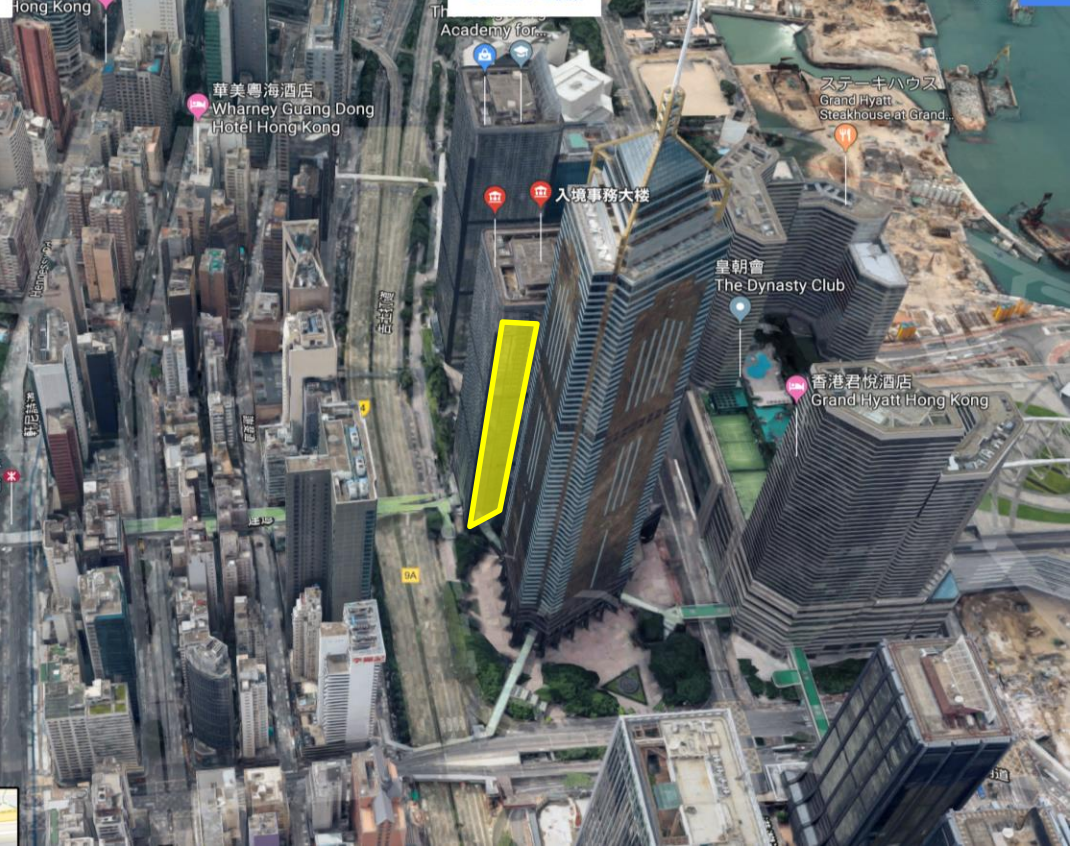
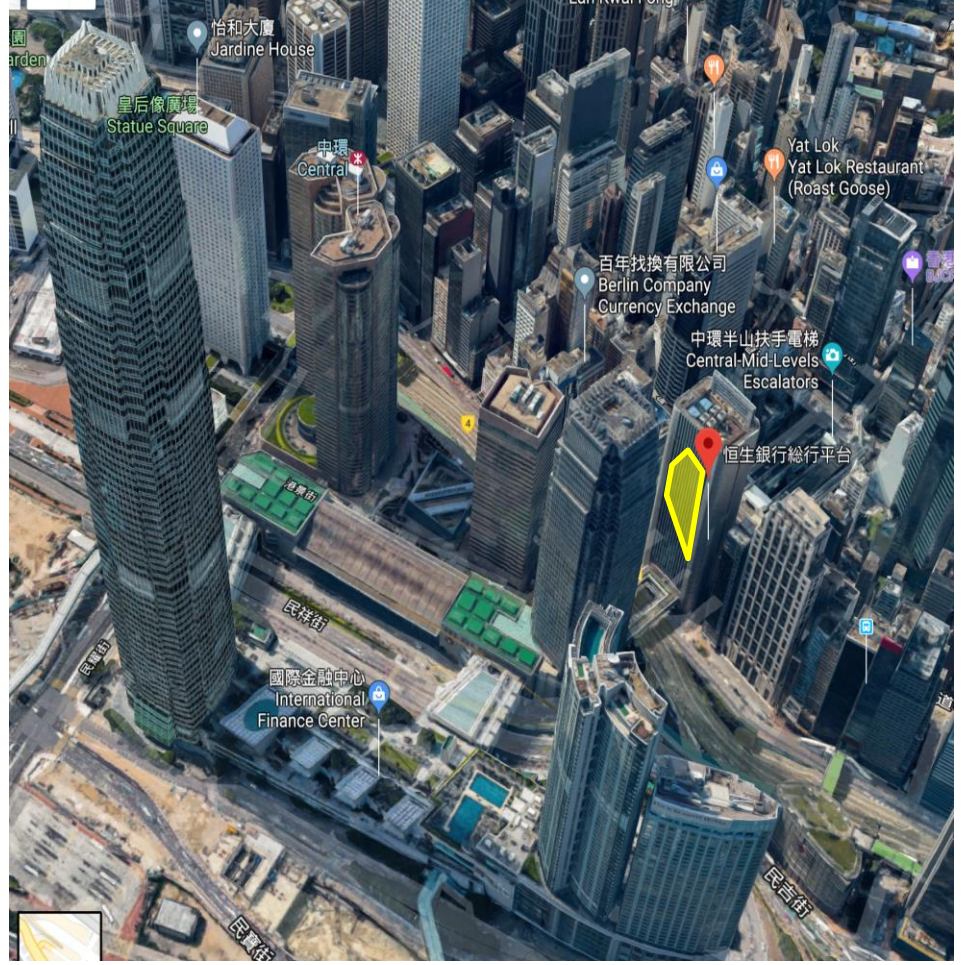
Mostly concentrated on one façade - location of the damaged face not facing the harbour

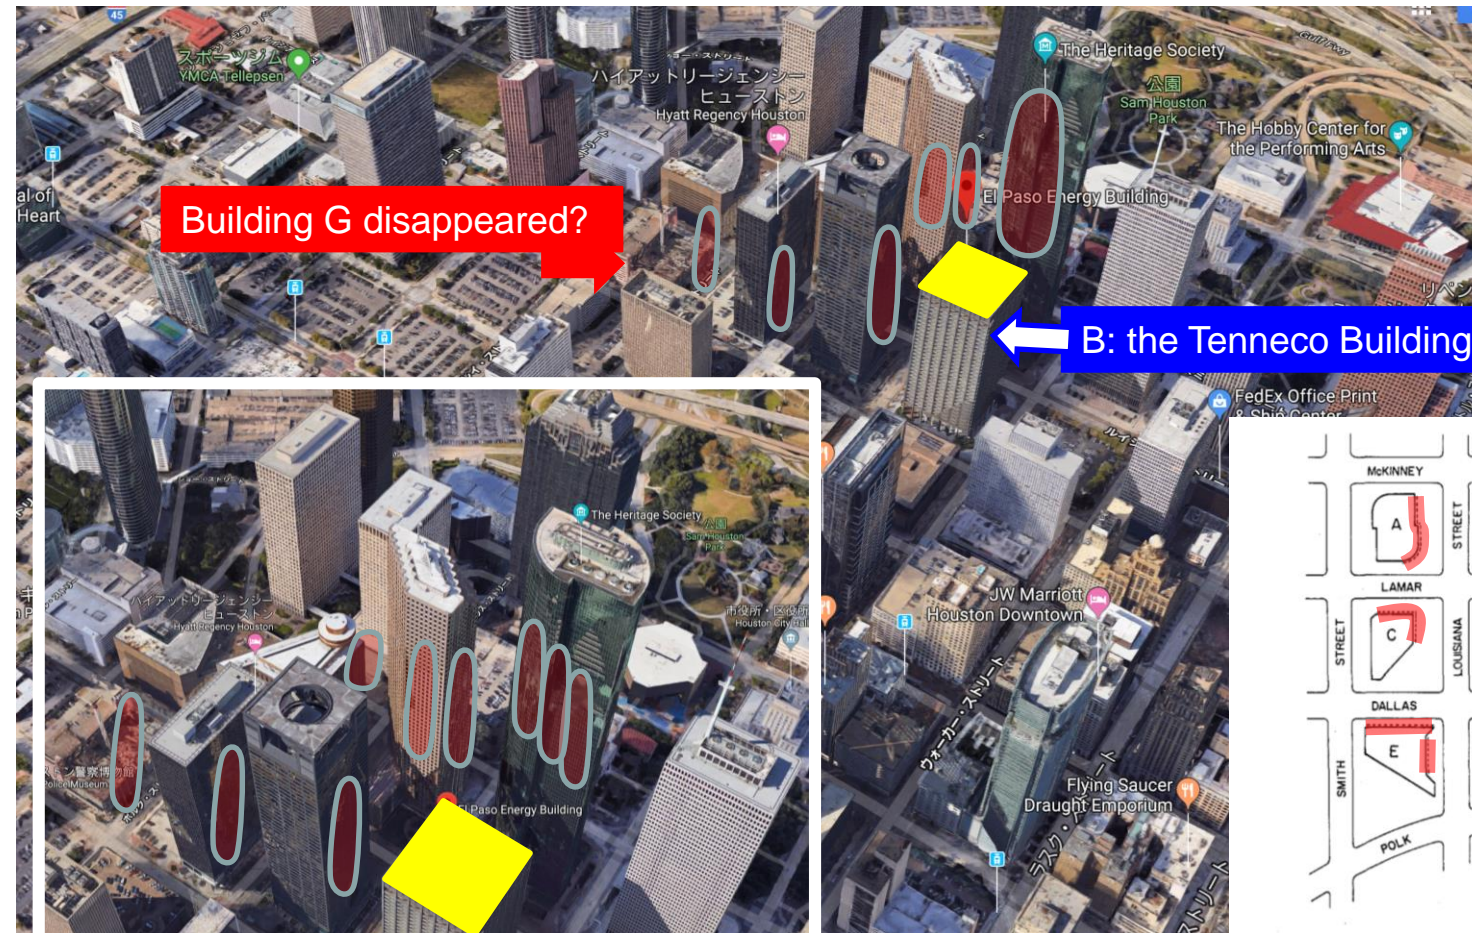
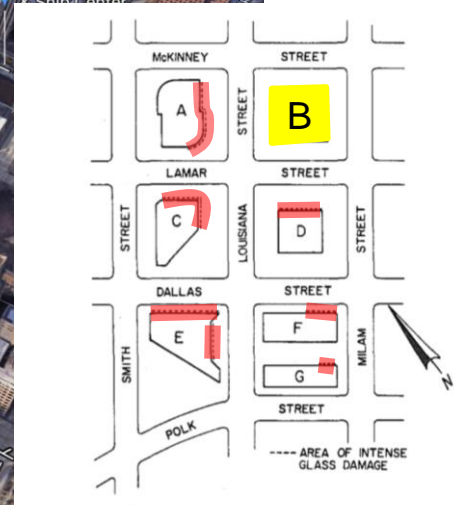
FIG. 1.—Plan View of Damaged High Rise Building Towers

- Wind pressure exceeding the design value,
- missile impact from windborne debris, and
- performance of glass under dynamic wind loading

“Analysis of these mechanisms suggests that impact from windborne debris, e.g., loose sheet metal, roof gravel, broken glass, and parts of the appurtenances from roofs, was the main source of glass damage.”

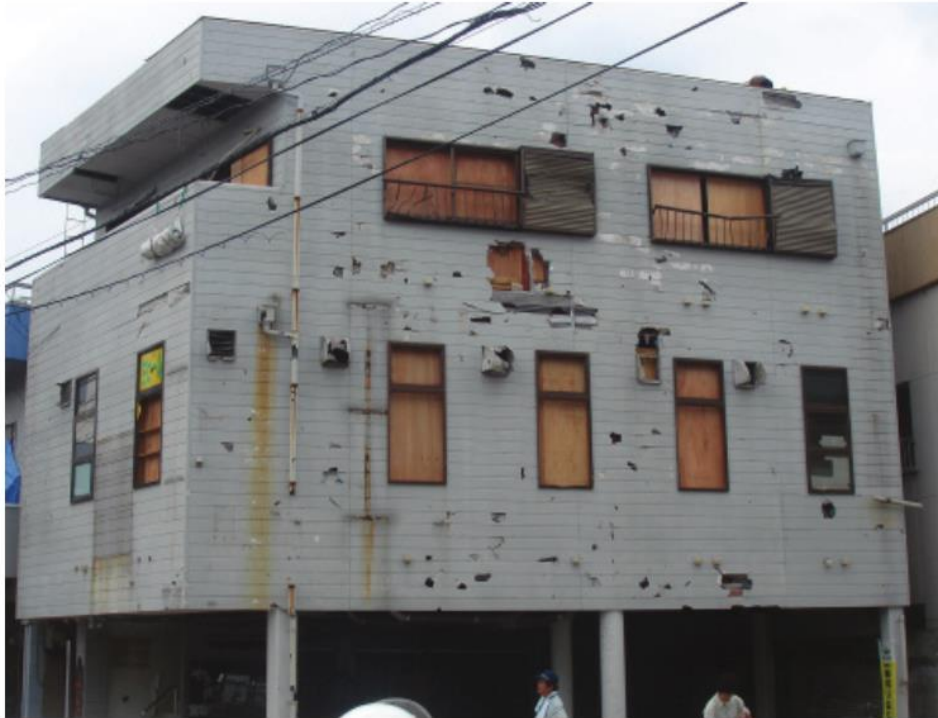
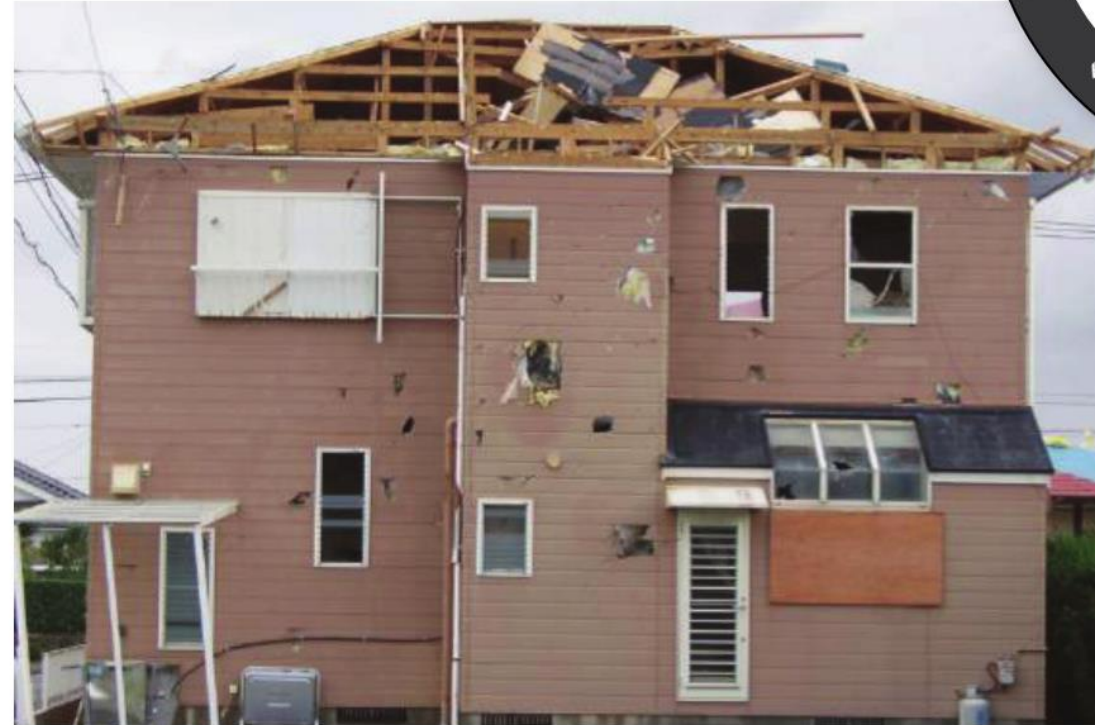
Figure 12: Damage Marks by Wind-borne Debris due to Tornadoes (Tamura, 2007)

(a) September 17th, 2006, Nobeoka-city

(b) September 5, 2005, Miyazaki-city
(courtesy of Miyazaki Meteorological Station)

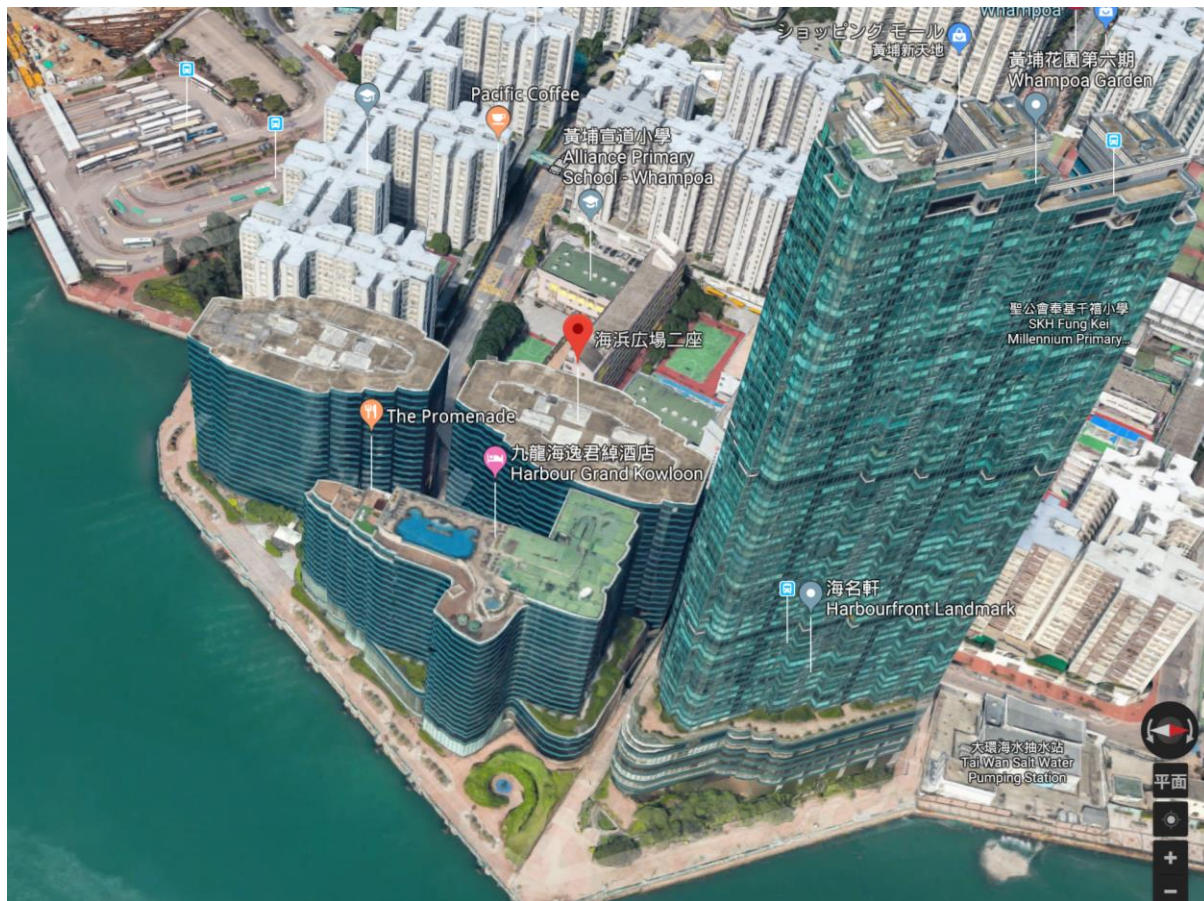
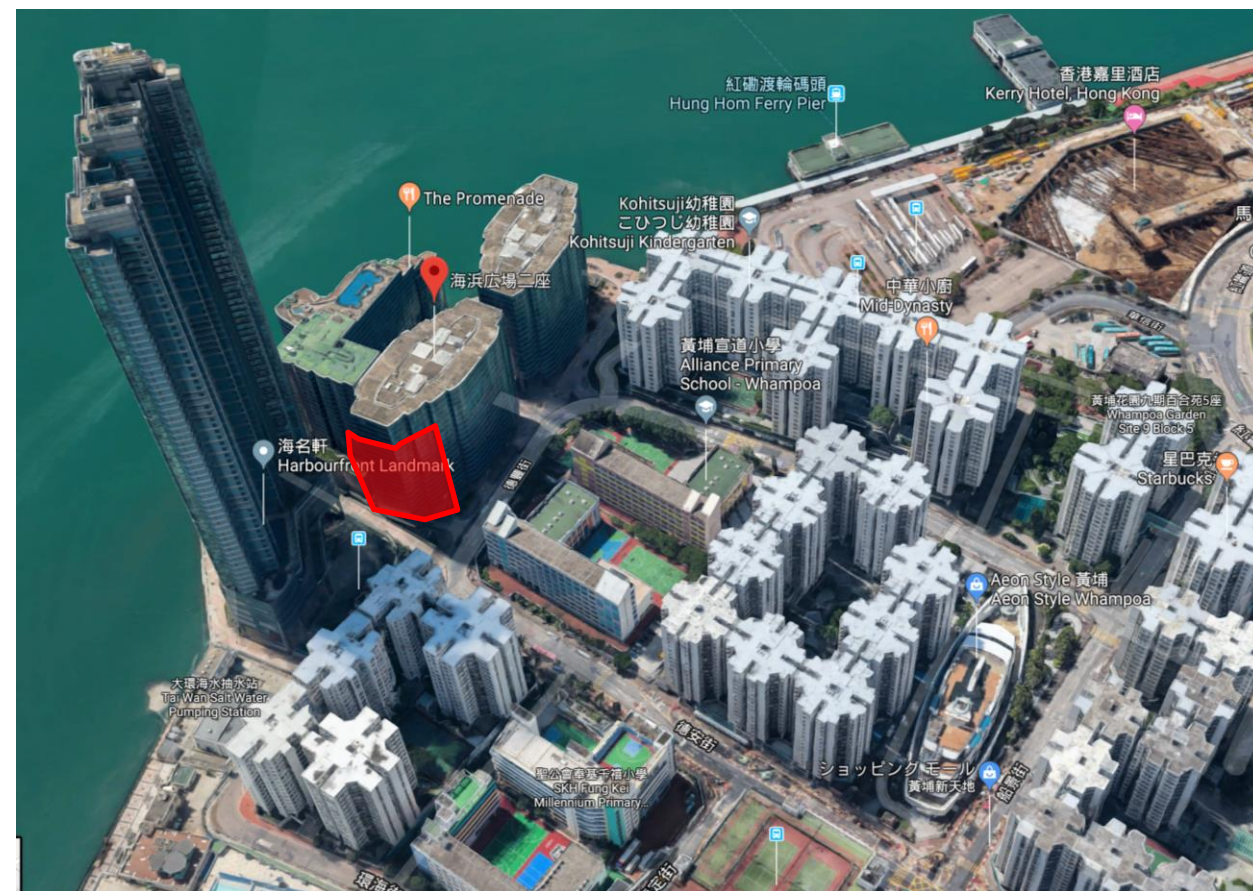
*Most damaged positions not facing the wind,
but somehow behind the first row of
buildings facing the wind*

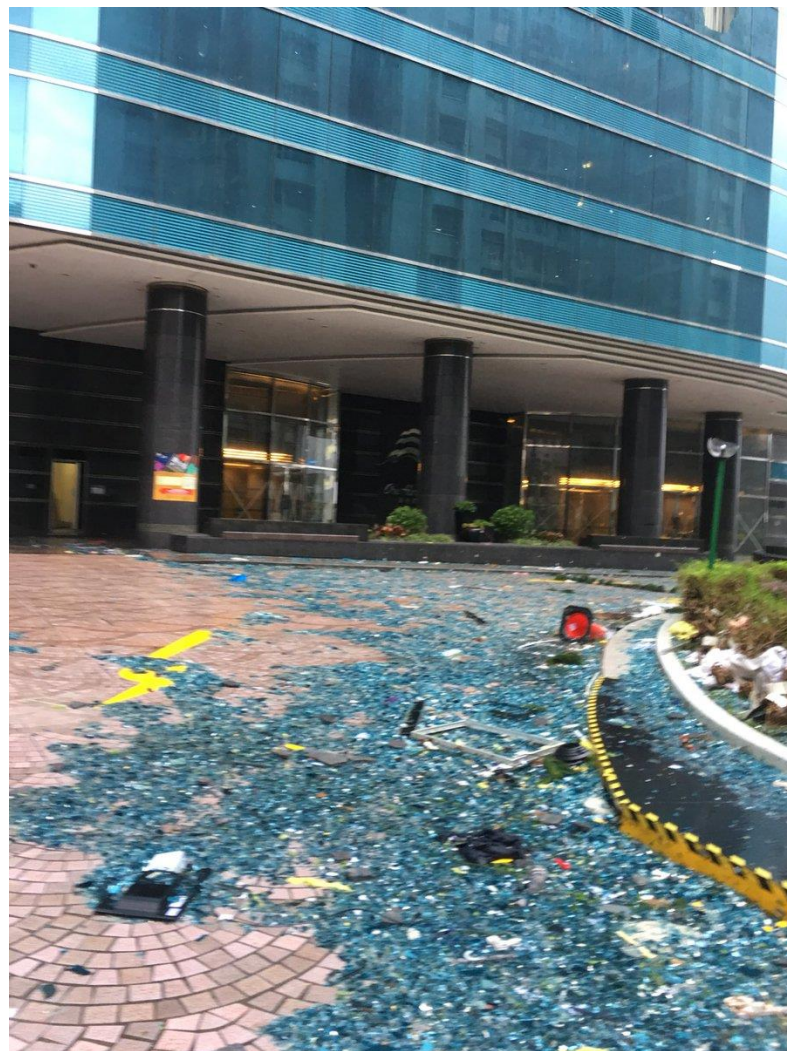
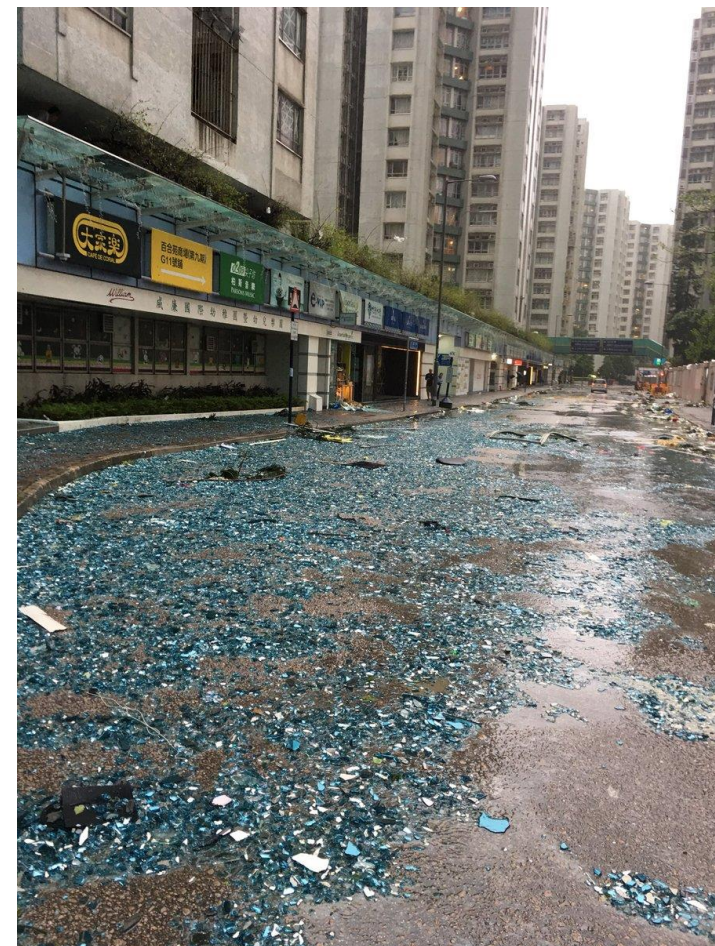
*Glass
fragments or
debris on the
ground,
mostly not in
the rooms*

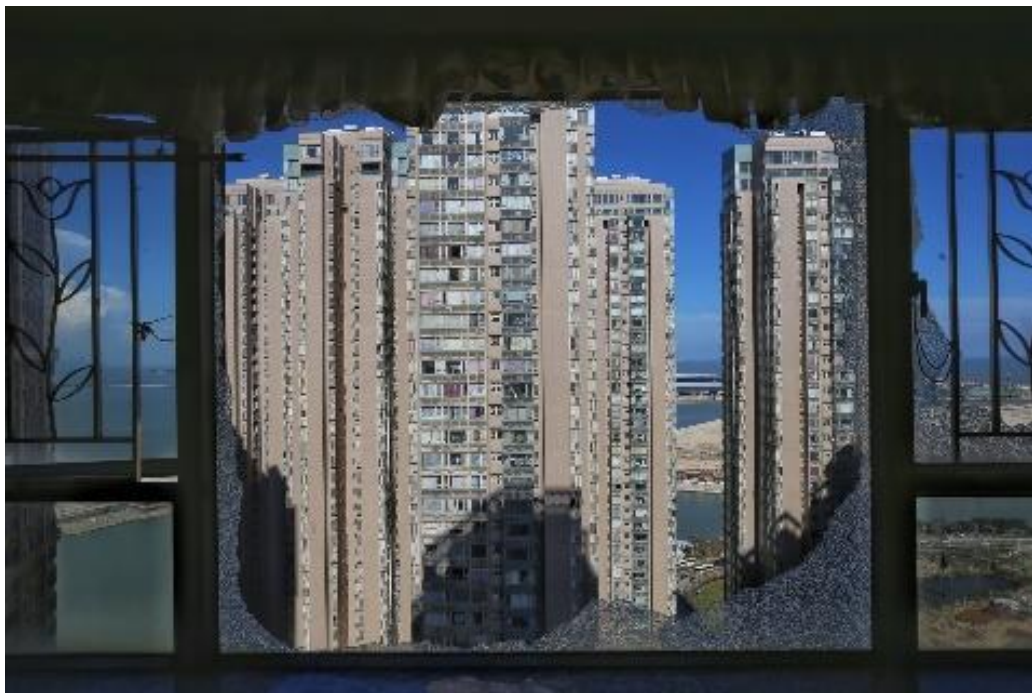
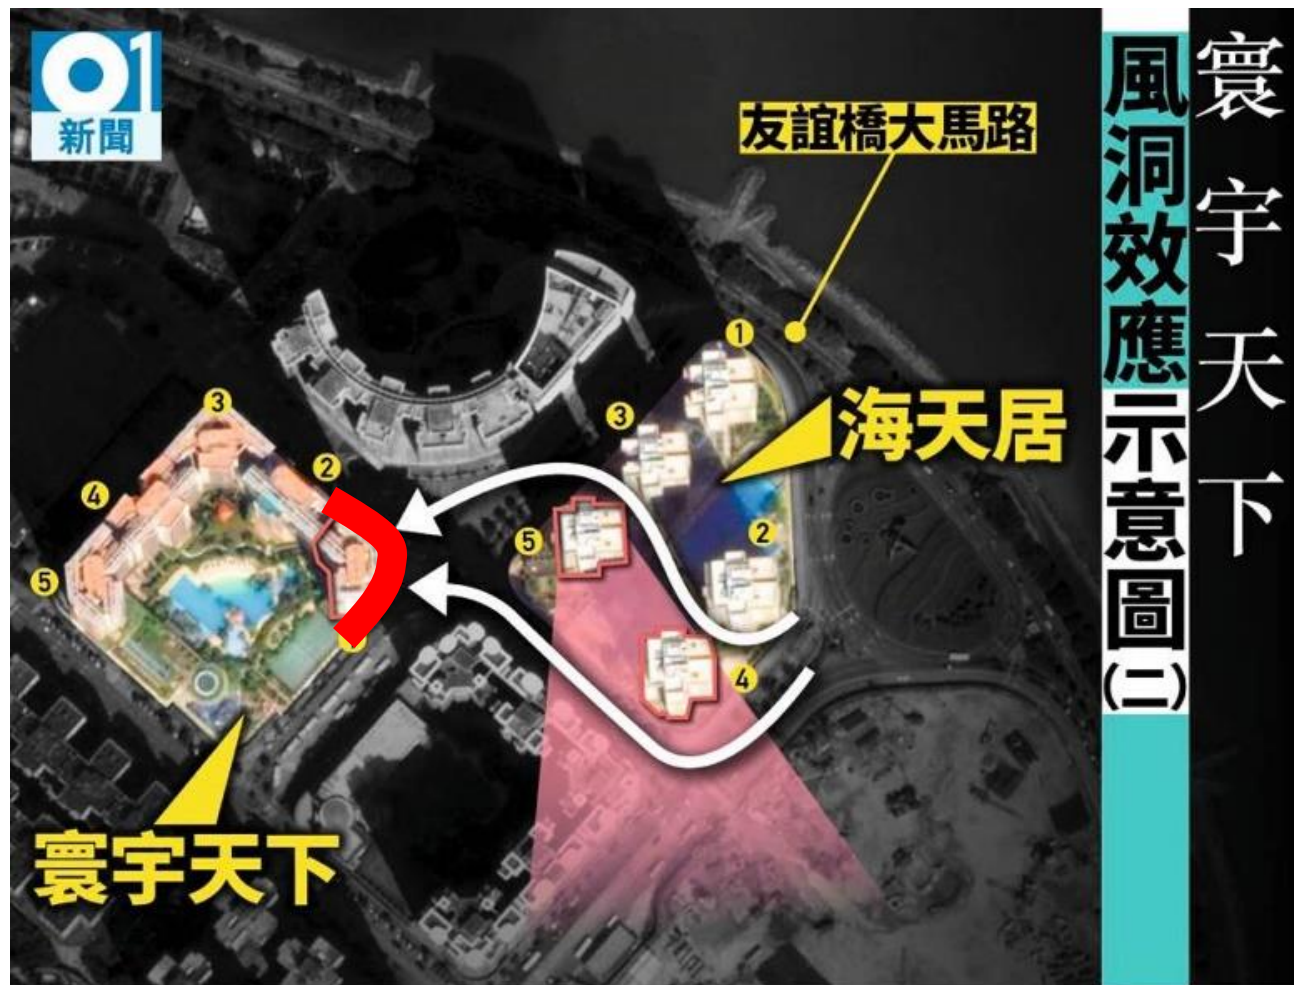
澳門寰宇天下

2012 July Typhoon Vicente
2017 August Typhoon Hato
2018 September Typhoon Mangkhut

海天居建成後，建築群與寰宇天下形成如漏斗形的隧道，強風經收窄後的管道，風壓更高，寰宇天下第一座成「食風位」，多個單位的玻璃窗分別在2012年及2017年颱風吹襲下被吹毀。
