# Impacts of Mangkhut on CLP Facilities

3 May 2019

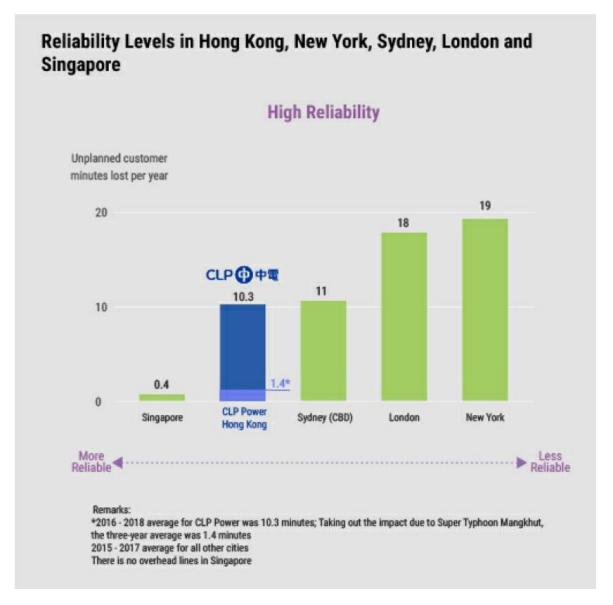
- Some customers in remote areas supplied by overhead lines suffered from prolonged supply interruptions.
- This significantly affected our unplanned customer minutes lost in 2018.

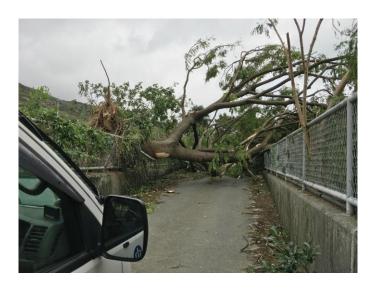
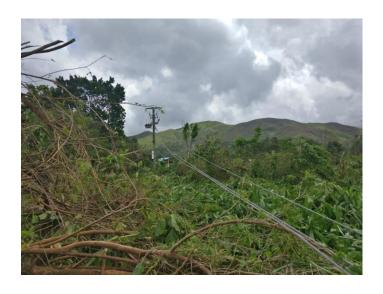
- Overhead line networks damaged by fallen trees and/or strong wind
- Blockage of access roads
- Adverse site conditions

- Replace pole-mounted transformers with Package Substations
- Equipment automation and remote operation
- Undergrounding overhead lines
- Vegetation management
